Manhole Inspection Summary

Manhole # S01EE2018MH

Insp Date: **7/24/06 9:09 AM**

Location Address: **6410 Cross Country Blvd** Cross Street: **Bancroft Rd**

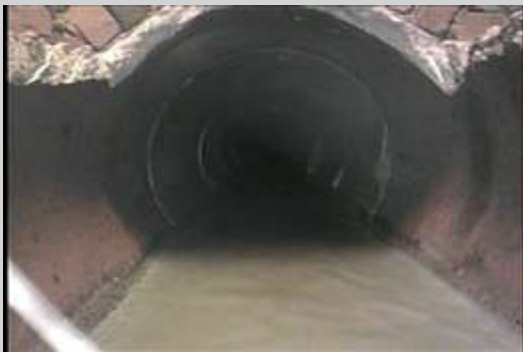
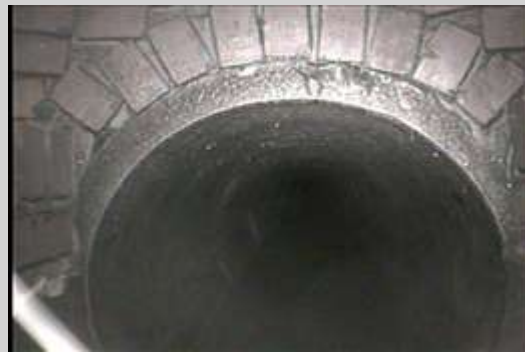
Pipe Out @ 12 O'Clock

21 in. Circular Gravity Sewer

Pipe Material: **Clay** ☐ Pipe Lined

Invert Depth: **9.15** (ft.) Flow Characteristics: **Fast**

Deposits: ☒ None ☐ Mud ☐ Sludge ☐ Debris ☐ Grease

Infiltration: **None** Pipe Seal Cond: **Sound**

Drop: **None**

Connects To: **Manhole**

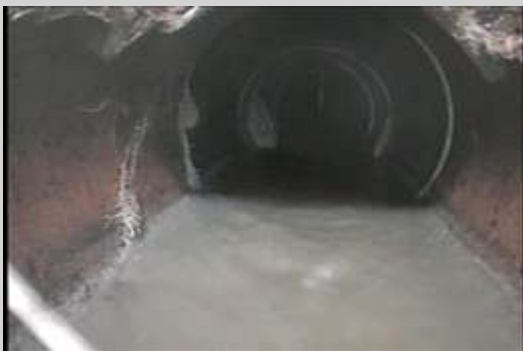
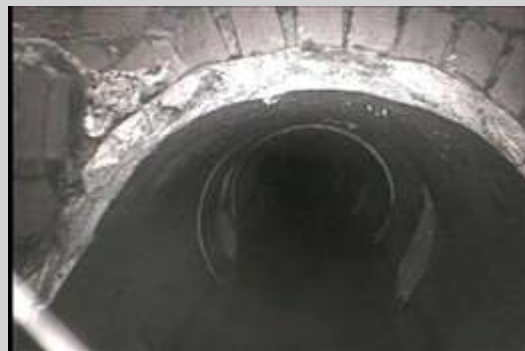
Pipe In @ 6 O'Clock

21 in. Circular Gravity Sewer

Pipe Material: **Clay** ☐ Pipe Lined

Invert Depth: **9.10** (ft.) Flow Characteristics: **Fast**

Deposits: ☒ None ☐ Mud ☐ Sludge ☐ Debris ☐ Grease

Infiltration: **None** Pipe Seal Cond: **Sound**

Drop: **None**

Connects To: **Manhole**

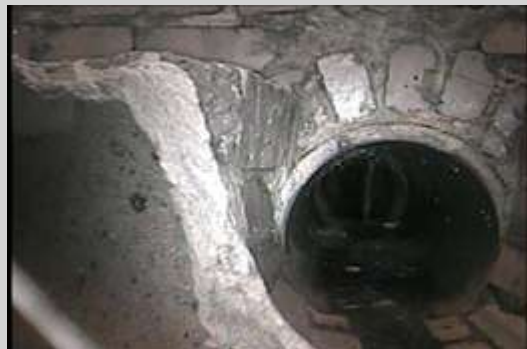
Pipe In @ 9 O'Clock

10 in. Circular Gravity Sewer

Pipe Material: **Clay**

Invert Depth: **8.70** (ft.) Flow Characteristics: **None**

Deposits: ☒ None ☐ Mud ☐ Sludge ☐ Debris ☐ Grease

Infiltration: **None**

Pipe Seal Cond: **Sound**

Drop: **None**

Connects To: **Dead End**
